Report

Pre-Program Waste Audit Recycling Drop-off

March 3, 2020

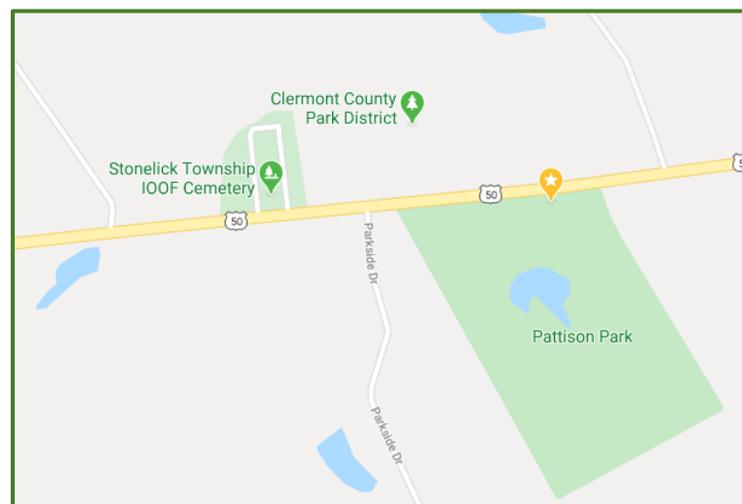
Figure 1. Pattison Park Drop-off Location

Recyclables materials were collected from residents at a public recycling drop-off site located at: 2228 US-50, Batavia, OH 45103. This site contains two 6-cubic yard front load packer style containers and is service by Rumpke four times per week.

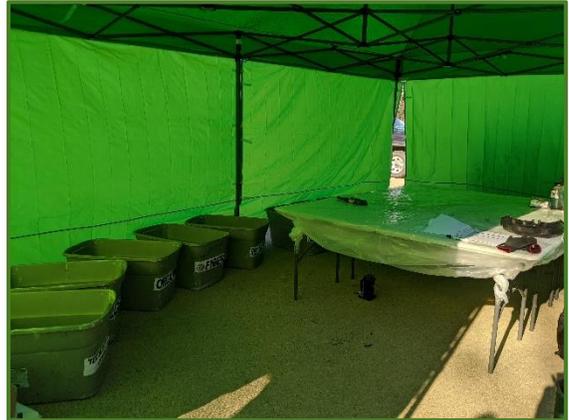
Prior to sorting, the sample was collected from the 6-cy container and weighed to obtain an initial weight. The initial weight served as a check and balance to ensure that all weighed components at the end of each sort matched the initial weight. The sample was placed on the sorting table and manually sorted into labeled bins. The sorters specialized in a material or material group (such as plastics or fibers).

Materials collected during the sampling period were sorted manually into pre-defined material categories and placed in containers for weighing and recording.

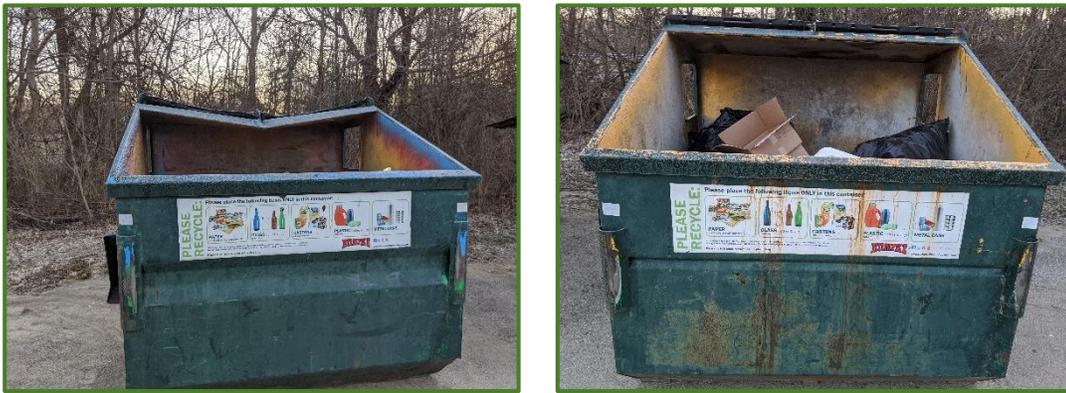
Figure 2. Pattison Park Recycling Drop-off Dumpsters

Two 6-cubic yard dumpster were sorted on February 21, 2020. The second dumpster, of the sort, contained 45% by weight bagged material. This was pulled and sorted separately.

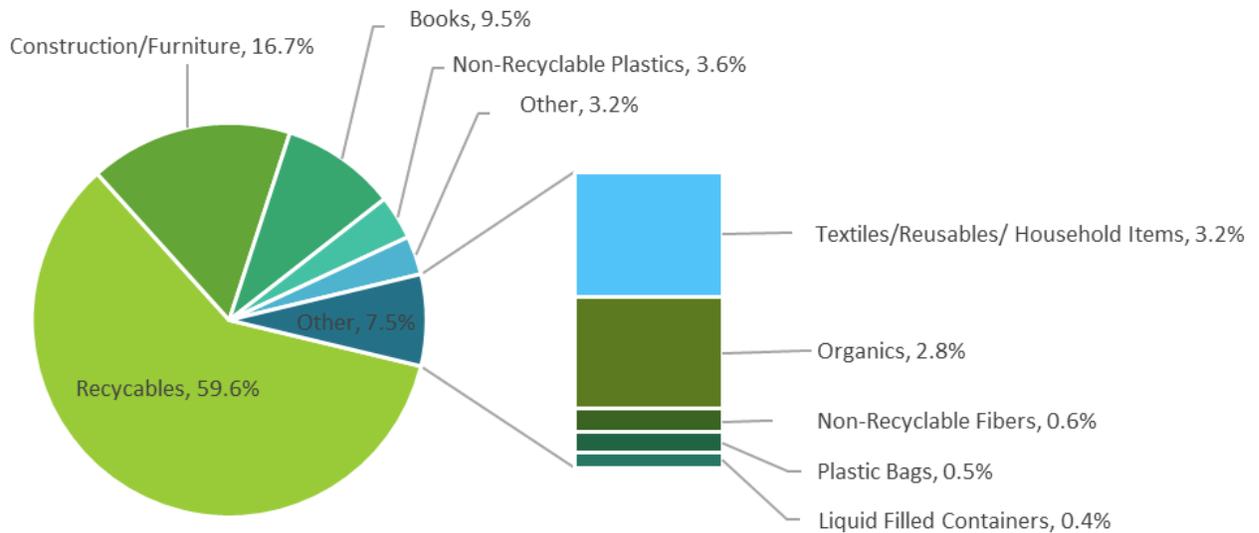
Figure 3. Comparison of Waste Audited (Loose Materials)

A total of 670.2 pounds were sorted during this audit. Out of this total, 395.7 lbs. were recyclable, and 274.5 lbs. were contamination or materials not acceptable in the program. The figure below shows the composition of the Pattison Park Recycling Drop-off.

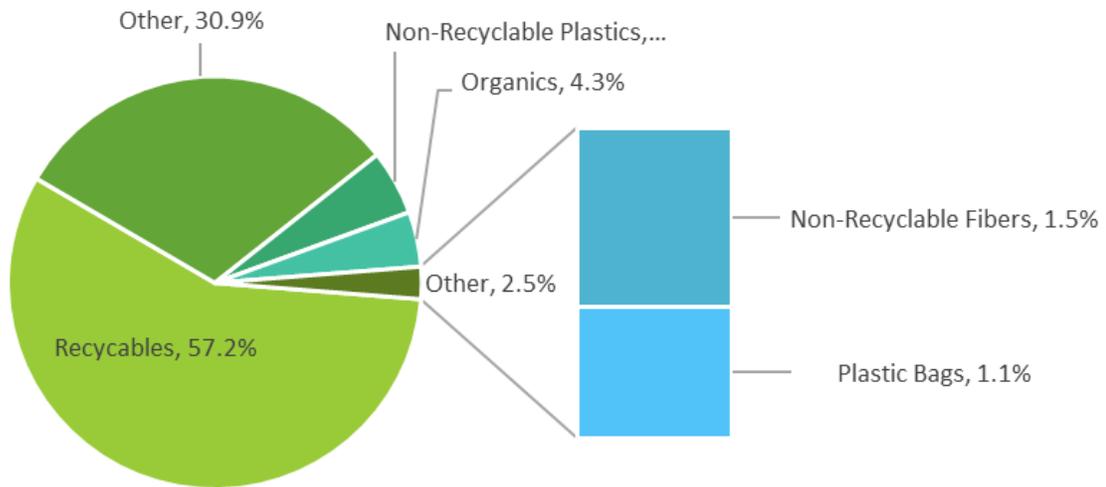
Figure 4. Comparison of Waste Audited (Bagged Materials from Dumpster #2)

Overall, 59.0% of the materials placed in the drop-off containers were recyclable. Bagged material was found to have fewer recyclable materials and many with little to no recyclable material. This sort was intended to provide baseline data for future education outreach to be provided by the Adams-Clermont Solid Waste District.
